Village of Pinecrest

Transition Plan

Appendix A: Accessibility Evaluation Report for Pinecrest Gardens

PINECREST GARDENS VILLAGE OF PINECREST, FLORIDA

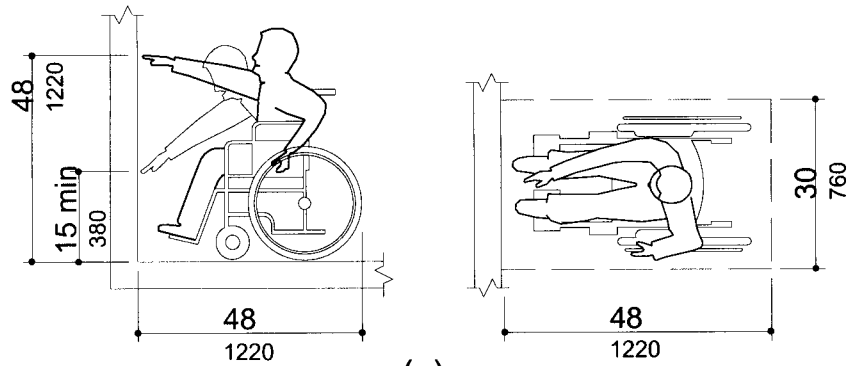
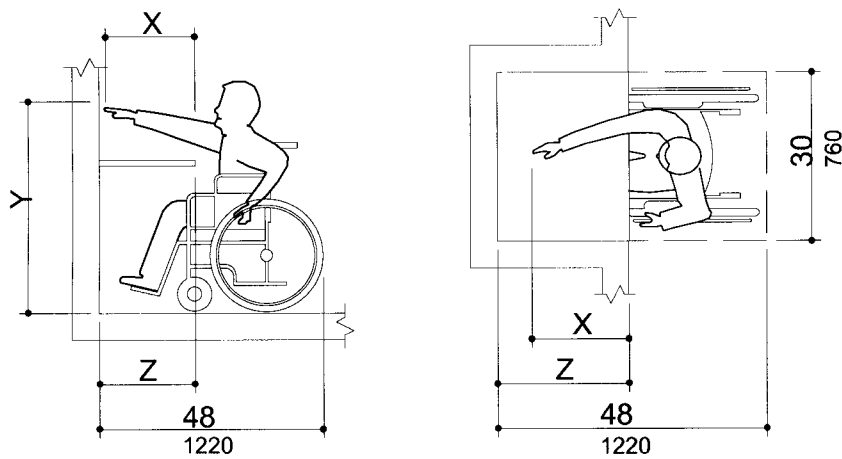
Fig 5
Forward Reach

Item	Area	Issue	ADA Code Reference	Proposed Corrections	Photo
14.	Fire Extinguisher Cabinet Inside The Hibiscus Room	Inside the Hibiscus Room there is a fire extinguisher cabinet located in the corner. Recommend lowering down the fire extinguisher cabinet to be at the appropriate reach range. The current mounting height to access the key lock is at a height 49½ inches above the floor; the centerline of the box is 59 inches above the floor. This fire extinguisher is one that a person would unlock and lift up. Consider lowering the fire extinguisher down, so the centerline of the fire extinguisher box would be at a height of 48 inches.	4.27.3 Figure 5 or 6	Consider lowering down the controls to provide the appropriate reach range to comply with Figure 5; maximum of 48 inches.	0501 0502 0503

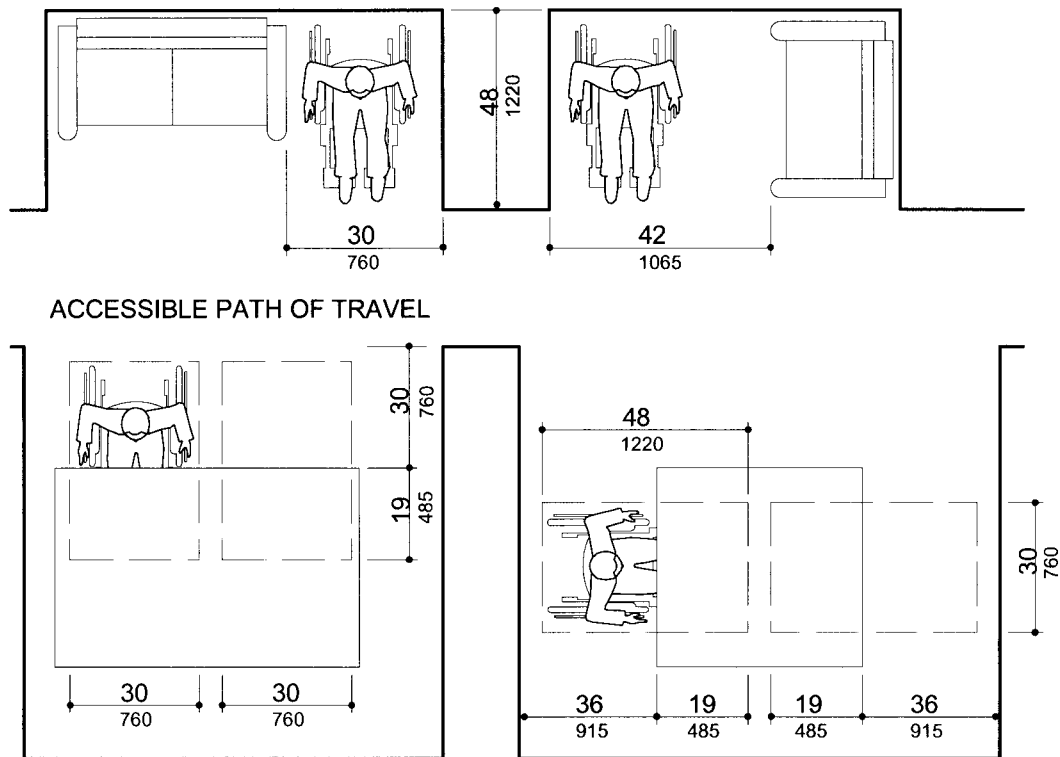
Fig 45
Minimum Clearances for Seating and Tables

58.	Tables And Benches – Lower Section By Playground Area	There is a lower section located by the playground area that has 10 tables which includes five tables with umbrellas.	4.32.3 Figure 45 4.32.4	Recommend to consider the new accessible tables at the north and south section to be the accessible tables in the area.	0725 0726

75.	Three Tables By The Counter For The Splash And Play Area	At this area there are three tables that are provided in the landscape area. Recommend providing an accessible table at this area.	4.32.3 Figure 45 4.32.4	Provide an accessible table with the knee clearance being a minimum of 27 inches high, a minimum of 30 inches wide, and a minimum of 19 inches deep to comply with Figure 45. The height of the accessible table shall be from 28 inches to 34 inches above the floor.	0809 0810
